Golden Rule

1 Brand New Home, Anywhere Texas

PROPERTY INSPECTION REPORT

Prepared For: Mr. & Mrs. New Homebuyer's
(Name of Client)

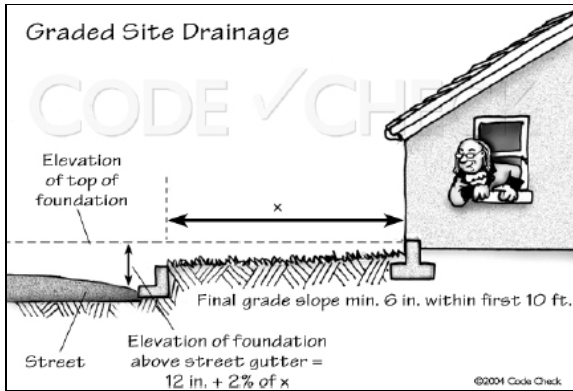
Slope of the ground away from the front right of the house is not in compliance; "grading specifications are spelled out clearly in International Residential Code (IRC) R401.3, "Surface drainage shall be diverted to a storm sewer or other approved point of collection so as to not create a hazard. Lots shall be graded so as to drain surface water away from foundation walls. The grade away from foundation walls shall fall a **minimum of 6 inches (152 mm) within the first 10 feet (3048)**". R 401.3 is not the only place in the code requiring this drainage provision. R506.1 and R 403.1.8 instruct builders building slab-on-grade residential buildings on expansive clay soils to adhere to an even stricter commercial building code, that of the International Building Code 1805.8.2, "Slab-on-ground foundations. Slab-on-ground, mat or raft foundations on expansive soils shall be designed and constructed in accordance with WRI/CRSI Design of Slab-on-Ground Foundations or PTI Design and Construction of Post-Tensioned Slabs-On-Ground." PTI Design is the Post-Tensioning Institute."

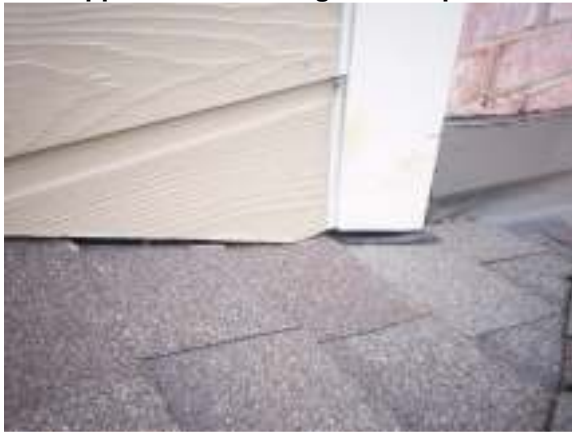
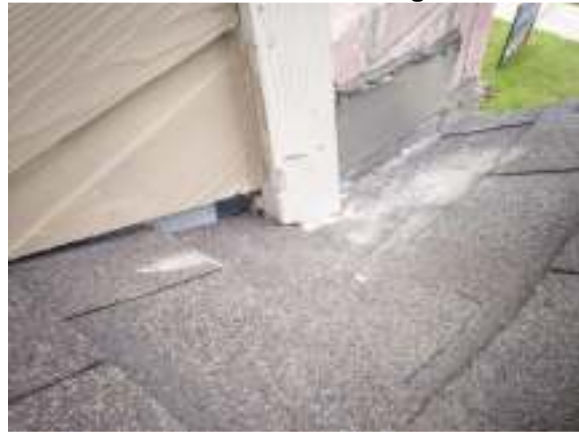
As seen on the roof, the siding is too close to the shingles and has caused a damming effect. Recommend the siding be raised up to 2" and the debris be removed. You will need to monitor this area and clean out any debris that accumulates and slows the water runoff.

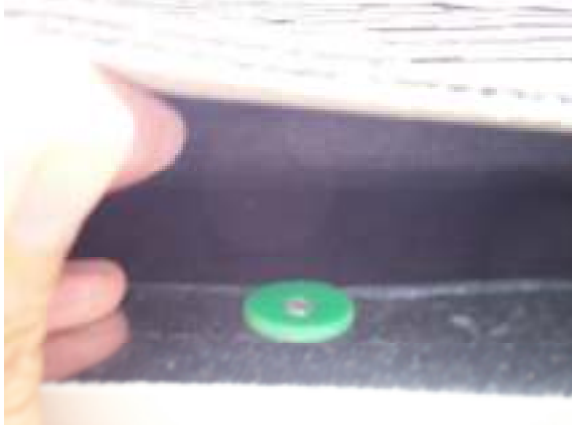
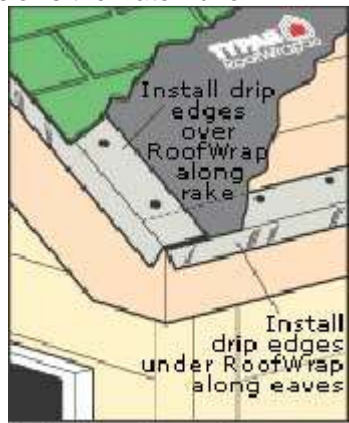
Installing drip edges:

The felt under the shingles is improperly installed. The shingle underlayment (felt or tar paper) is required to lap over the drip edge flashing at the eaves and to go under the drip edge flashing at the rakes of the roof as per the shingle manufacturers installation instructions; the Nat'l Roofing Contractors Association's Roofing and Waterproofing and per IRC R905.2.8.1.

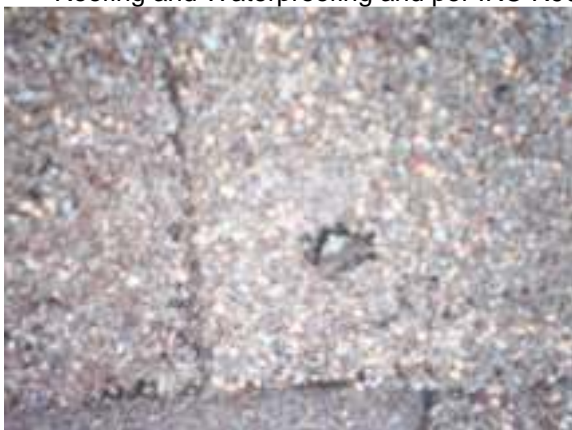
Inspector noted nail heads protruding through the shingles from them not being driven in all the way, recommend all of these be sealed.

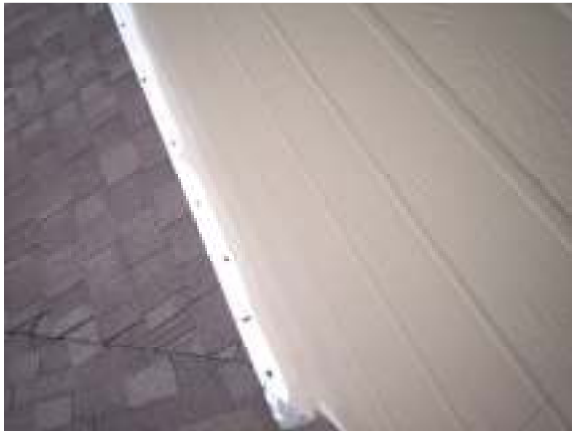
The flashing on the right side of the roof was not painted as the rest of the roof to wall flashing was.

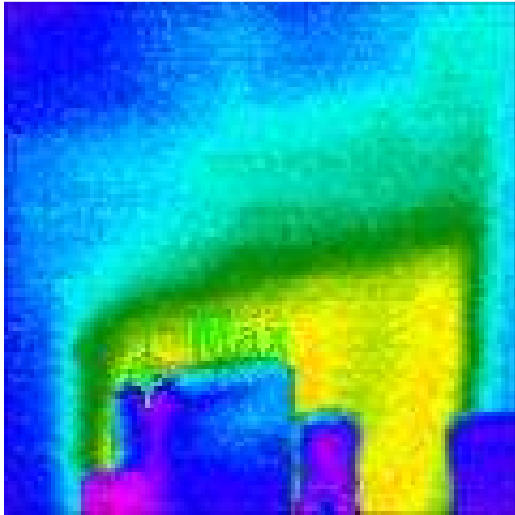
Infrared thermography scan of the upstairs right rear bedroom, missing insulation noted behind the bookshelf. From that attic this inspector could see that the missing insulation was an attic access hole that was never sealed. Both sides of this room have 4'X4' missing insulation.

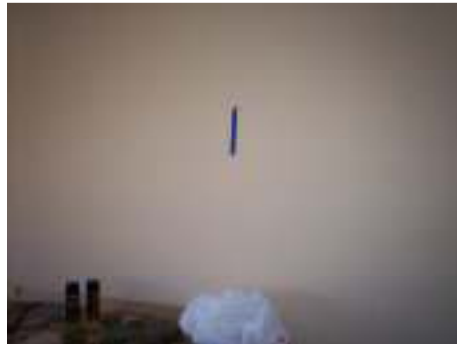
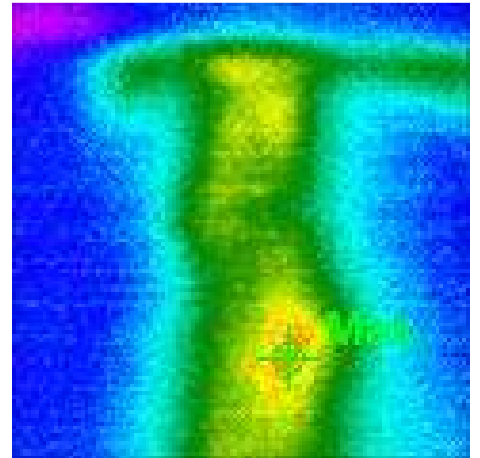
IR scan shows heat in the wall

Heat anomaly noted in the wall of the garage over the table with the rocks, (it ran from the ceiling to the floor), this appears to be either a hot electrical line or a hot water pipe that is close to the wall. Recommend checking the blueprints and verifying which is present, if it is an electrical line it should be repaired as it is running hot, if it is a drain line then it should be ok.

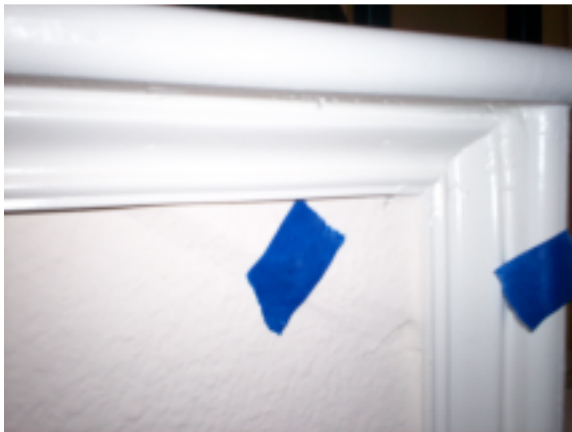
Drywall flaws, paint flaws, nicked corners, minor cracks, missing paint, multi color areas marked throughout the house with tape. Recommend correction as needed. Look at the area under the 2nd or 3rd step, this looks like an entire corner of sheetrock broke off and was just slapped back on.

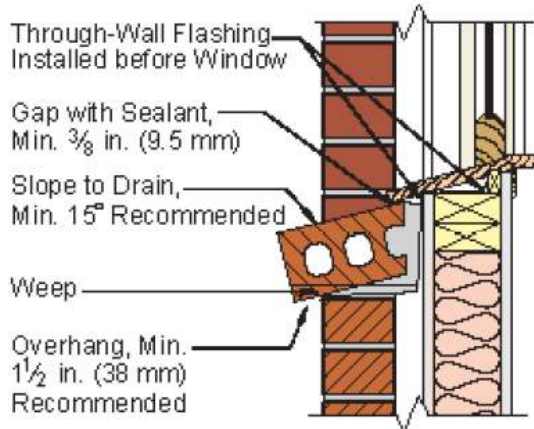
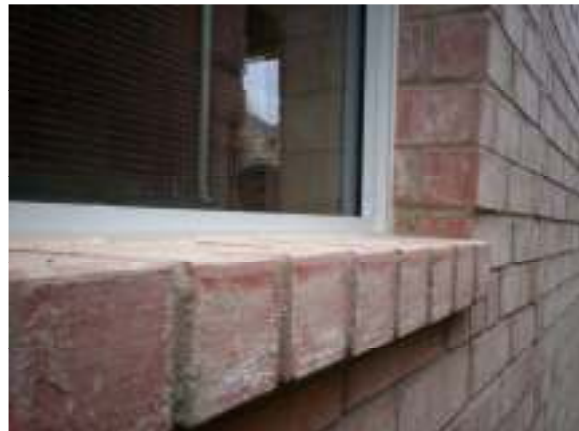
The slope of the window sill bricks on the exterior of the house is not enough to allow water to drain away "The prime function of a sill is to channel water away from the building". Window sills shall be sloped to drain, a minimum of 15° is recommended. Ref Brick Industry Association Tech note 7, and Tech Note 36.

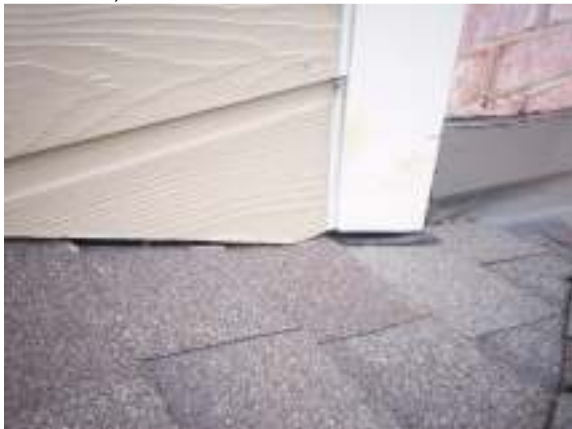
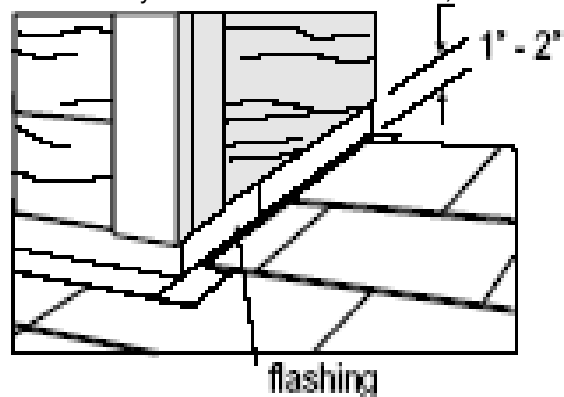
The siding should not be in contact with the roof surface. Per the Manufacturer It must be installed a minimum of 1"-2" above the roofing surface.

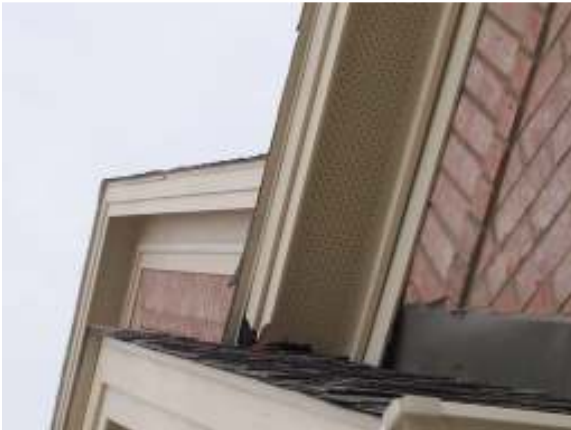
As seen over the left garage door at the dormer, the fascia and soffit boards were cut using a hammer, this is not a professional way to trim a house out. I recommend that these boards be removed and the correctly cut boards be installed.

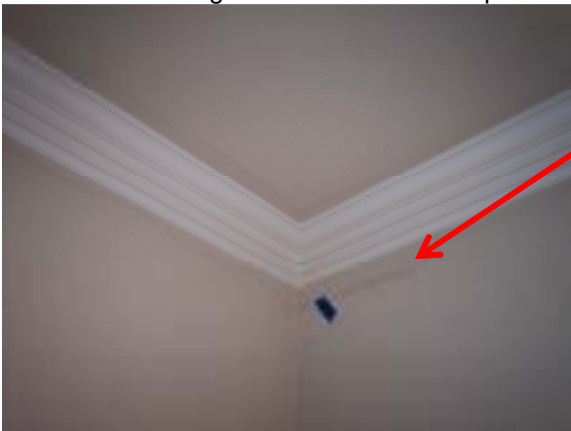
Water stain, no water detected at this time.

Water stain was noted in the ceilings in the guest and master bathrooms (no evidence of moisture presence at this time). The cause and remedy should be further evaluated and corrected as necessary.

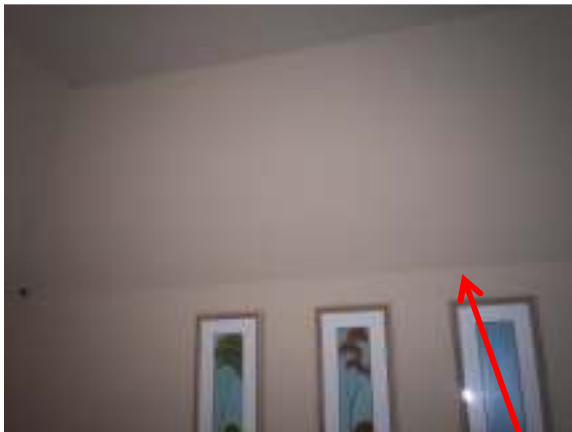
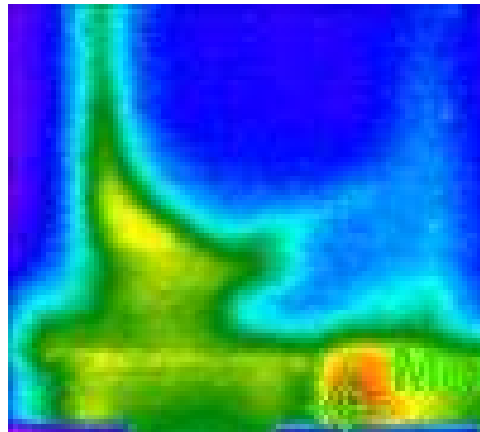
Lacking insulation noted in the ceiling of the front left bedroom over the head of the bed as seen with an infrared thermography camera. Recommend correction as needed.

The hottest spot is here, the angled ceiling in this area has several areas of missing insulation, over these pictures and at the front corner toward the front of the house from these pictures.

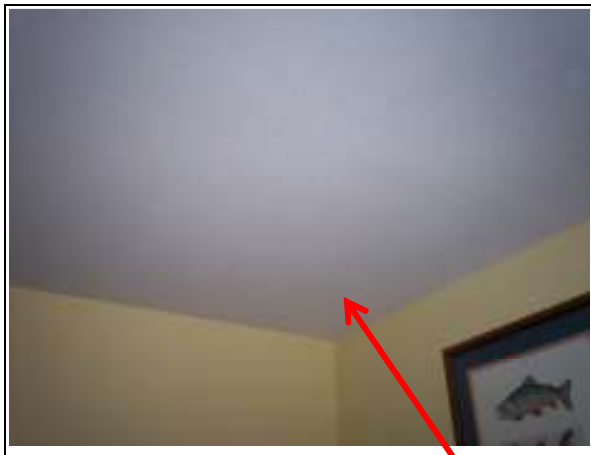
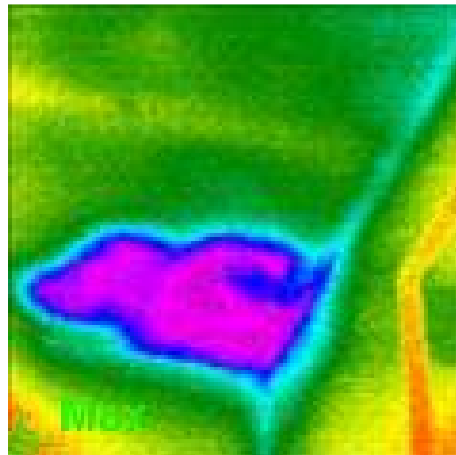
Water stain noted in the ceiling under the Jack & Jill bathroom as seen with an infrared thermography camera. Inspector verified the presence of water with a GE Protimeter Surveymaster dual mode pin and non invasive moisture meter. Any moisture reading over 16% relative humidity makes the area conducive to decay, mildew, mold, and wood destroying insects. Recommend investigation and correction as necessary to stop the water penetration.

There is water present at this location, it cannot be seen with the naked eye but the Infrared Thermography Scan detected this leak. Repairs are needed.

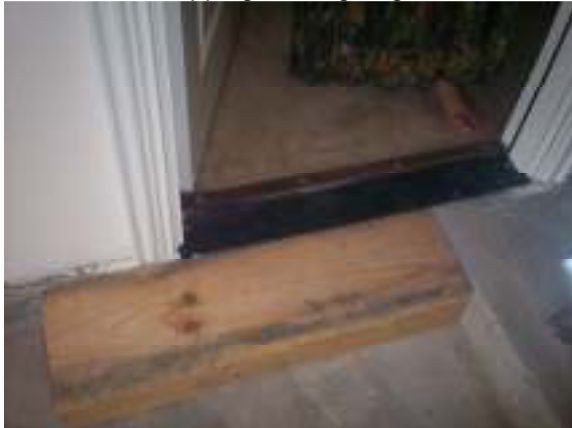
The landing outside the garage man door should be better built. This could be a safety problem.

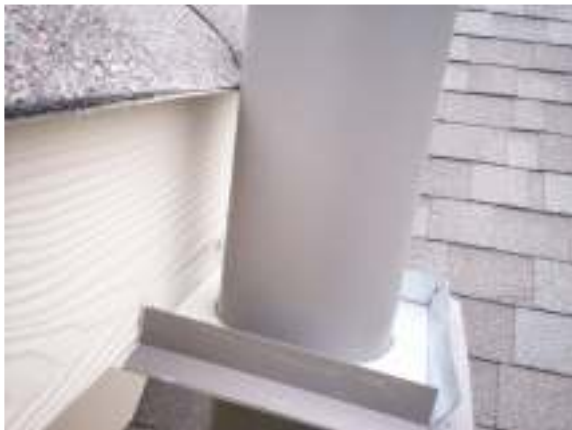
NOTE: the chimney is required to have one inch of clearance from combustibles, if it touching the shingles, recommend correction.

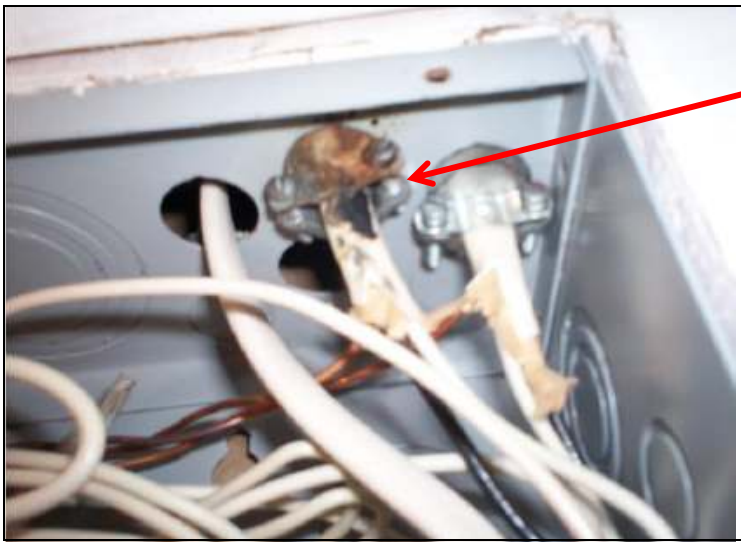
Burned wire as seen inside the electrical panel, very dangerous.

Inspector noted a branch circuit wire in the main panel that had arced and burned the insulating jacket on the wire, this inspector notified the builder directly and shut this circuit off. This is a safety issue and should be repaired immediately for safety reasons.

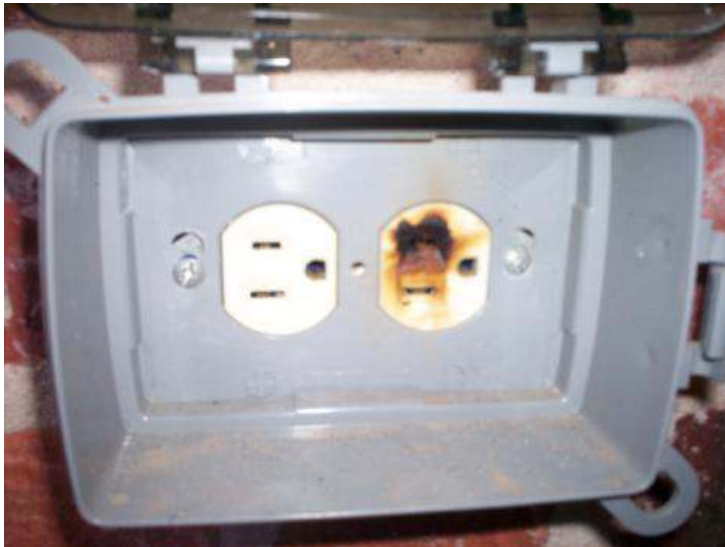
There is a burned outlet at the exterior of the house near the front door. Repairs are recommended for safety.

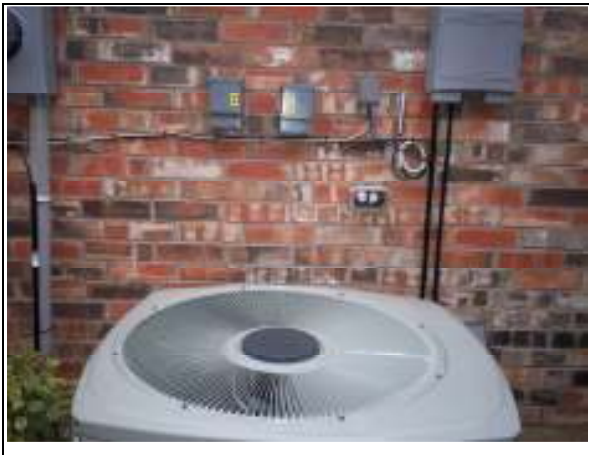
The electrical disconnect panel(s) for the air conditioner(s) condenser units should be moved to an appropriate location. Per IRC E3305.1 &.2 and NEC 110-26a they should have at least 36" deep by 30" wide clearance in front of the panels. The IRC Commentary specifically notes "When a worker is standing in front of a panelboard or air conditioner disconnect switch, for example, he or she should be able to walk up to it and stand in a clear space with no obstructions without having to lean or climb over another piece of electrical equipment or other obstruction". Recommend correction as needed. Note, many cities allow this current yet incorrect installation.

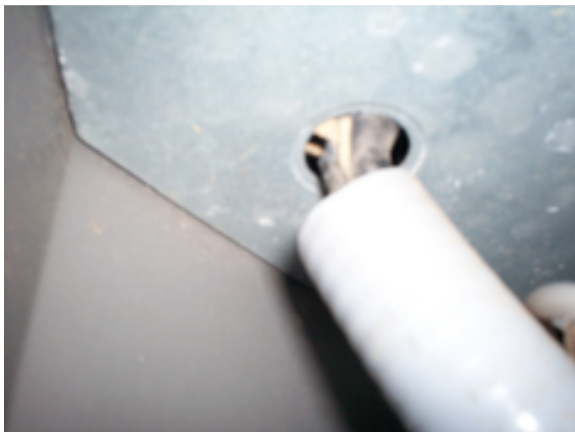
The electrical wire conduit connection going into the condenser has come loose. Recommend it be re-secured.

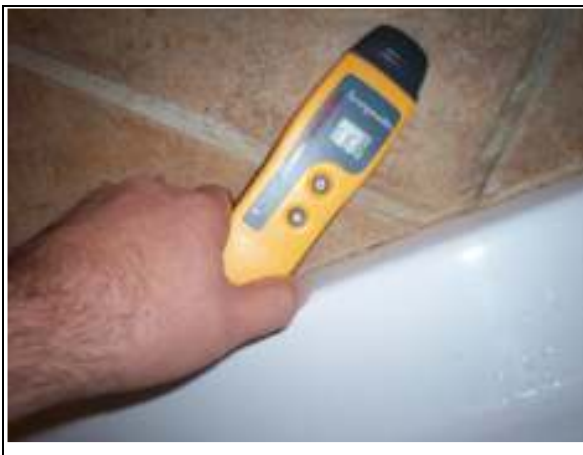
Inspector verified the presence of water behind the master shower with a GE Protimeter BLD 1200 surveymaster dual scan, moisture content is too high. Any moisture reading over 16% relative humidity makes the area conducive to decay, mildew, mold, and wood destroying insects. Recommend investigation and correction as necessary to stop the water penetration. Any wall or floor damage found beneath the enclosure should also be repaired.

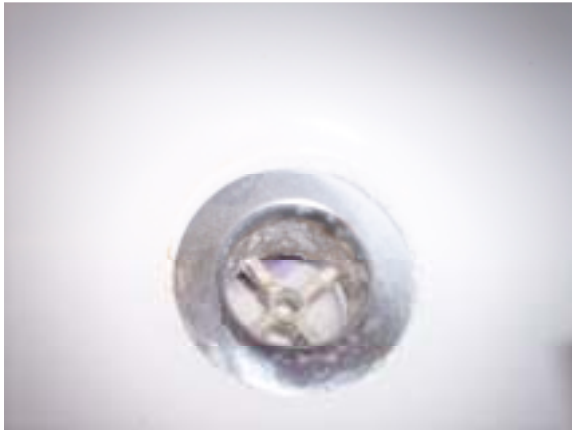
The rear upstairs drain in the tub appears to have been fixed while wet. The paint bubbled and looks bad, recommend repairs.

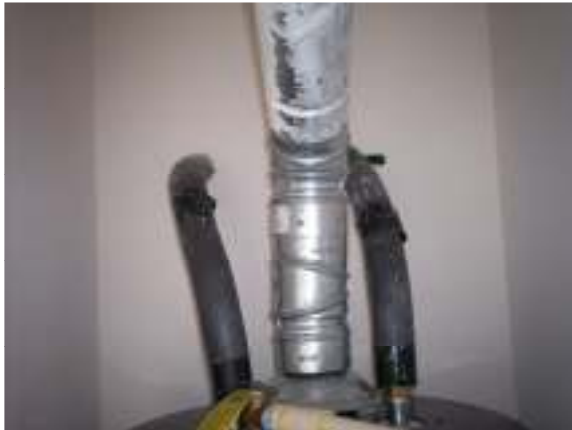
Normal water temperature is 120° - 140°. Water temperature is 125° as measured at the sink in the hall bathroom.

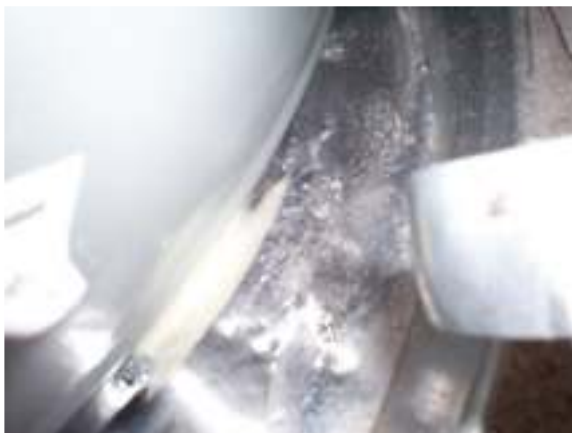
The pan installed below the water heater has holes in it. Recommend correction.

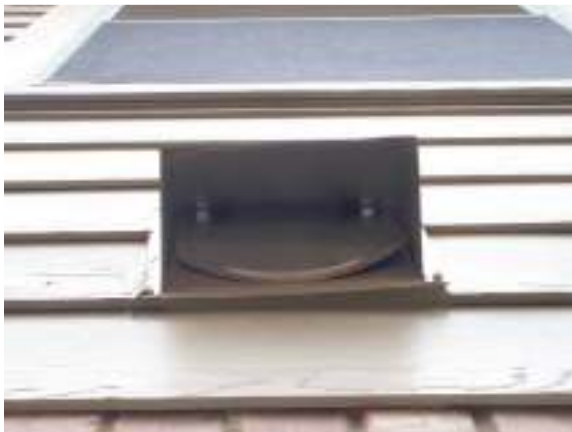
Vent cover for the range exhaust vent is damaged and does not seal well, recommend repairs.
