# Golden Rule Property Inspections, LLC

# PROPERTY INSPECTION REPORT

**Concerning:** 123 Main Street, Great Town, Texas

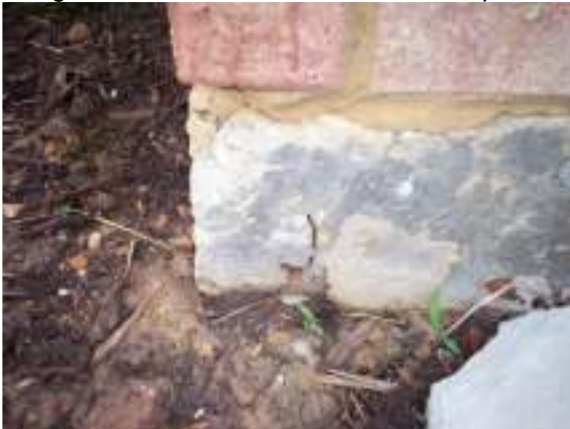
**One or more of the concrete corners of the slab are sheared off somewhat (corner pop), right front corner. This is a common condition in slab on grade foundations. This condition does not adversely affect the performance of the foundation. However, in some cases, some cosmetic improvements may be necessary.**

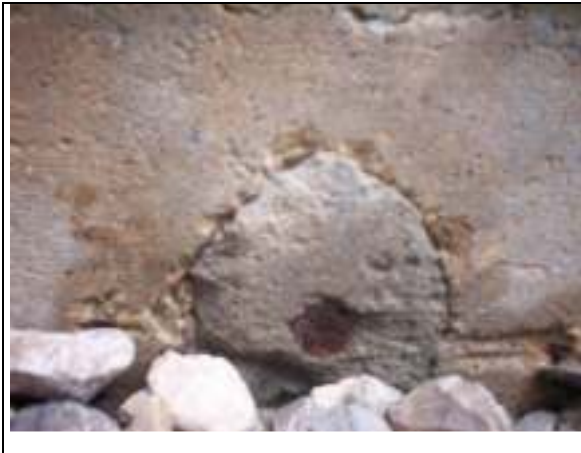
**Post tension cable ends were observed on the exterior of the foundation along the left side of the house. This should be repaired to prevent corrosion. Patching with a Non Shrink grout found at most home improvement stores is normally a very simple fix.**

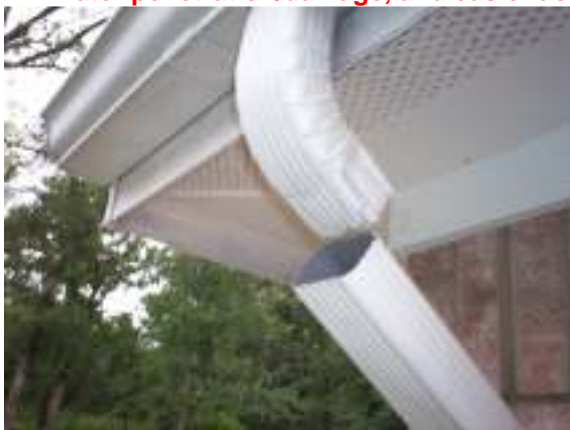
**The downspouts at the rear of the house have separated and should be re-secured.**

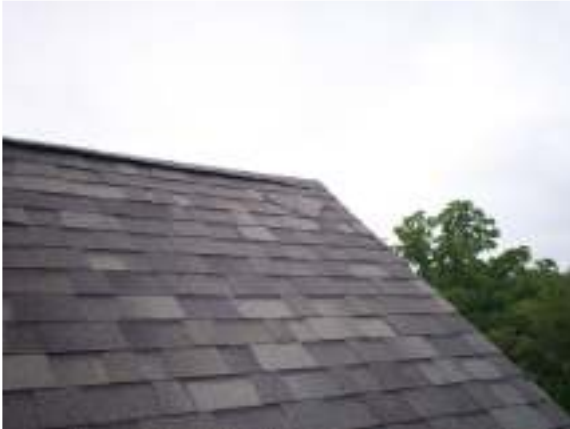
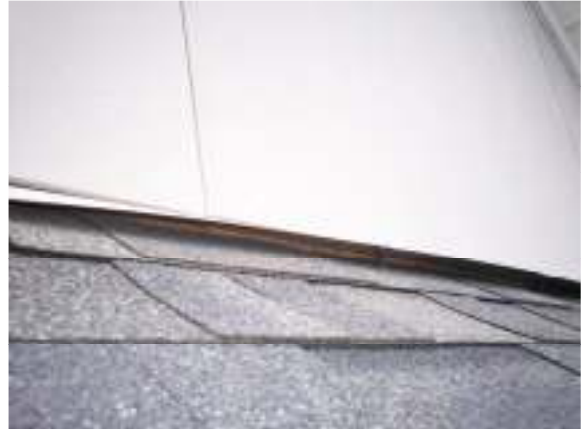
Loose shingle tab noted over the master bedroom area, recommend this tab be re-secured. The flashing over the front porch should be re-secured.

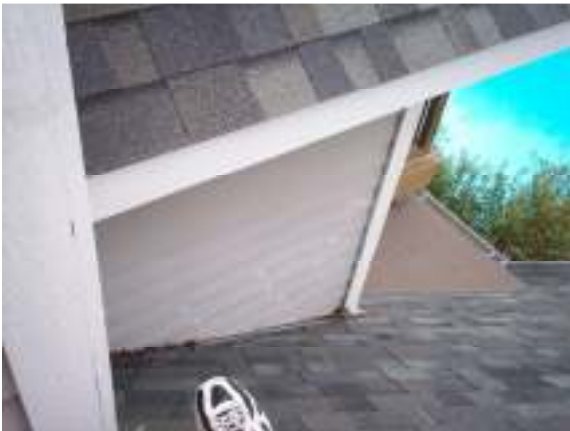
As seen at the rear slope on the roof, the siding is too close to the shingles and has caused a damming effect. Recommend the siding be raised up to 2" and the debris be removed. You will need to monitor this area and clean out any debris that accumulates and slows the water runoff.

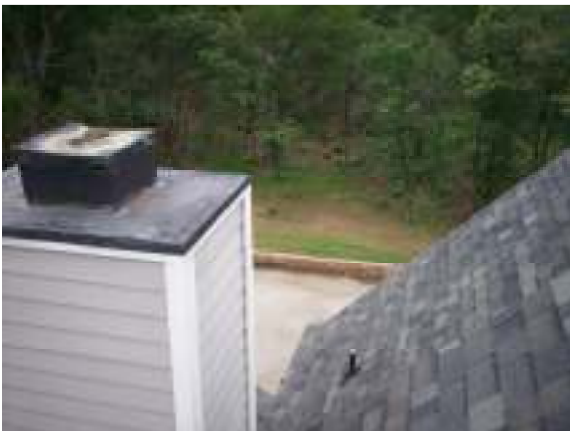
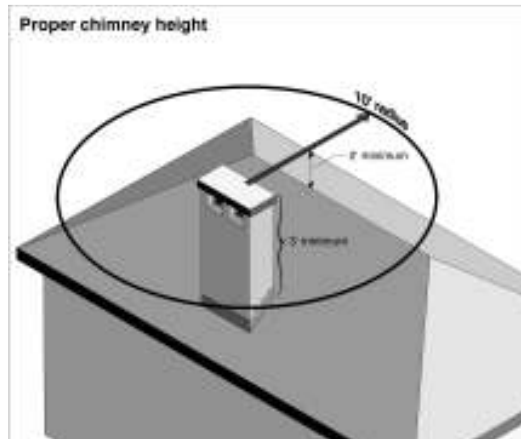
Chimney height does not appear adequate per current industry standards (Code) to ensure proper draft of fireplace. The chimney should extend at least three (3) feet above the point passing

through the roof and at least two (2) feet higher than any part of the building within ten feet, unless allowed per manufacturers instructions. Recommend further evaluation and repairs by a qualified contractor.

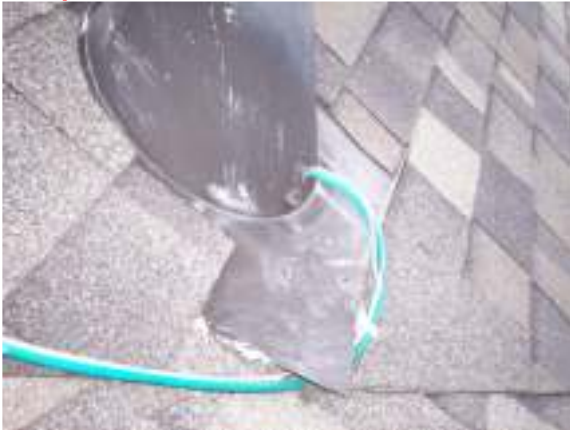
The internet connection on the top of the roof, the cable is nailed to the roof, and the cable runs into the house through a hole drilled in the flashing. This is contrary to good construction practices. I recommend removing the cable as it will tend to decrease the life of the shingles, covering all the holes with roofing caulk.

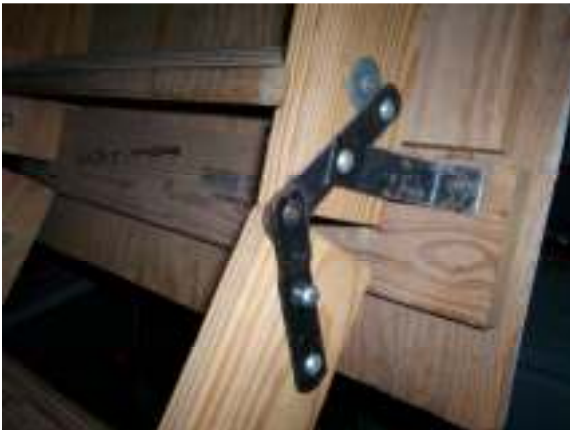
Attic access ladder legs hyper flex when in the open position, this decreases the weight holding capacity and should be repaired for reasons of safety. Also there are many missing nuts and bolts on this ladder, this unit should be repaired for safety reasons.

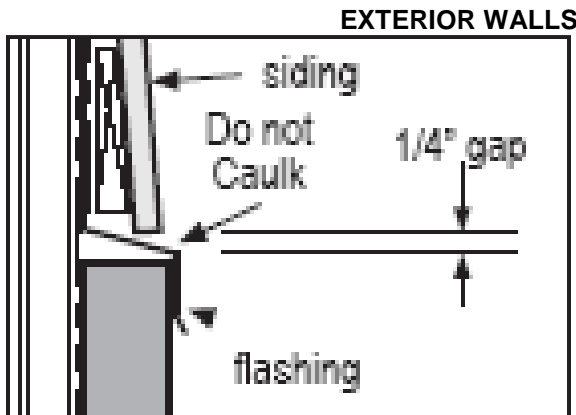
All horizontal surfaces over doors and windows, and horizontal trim boards, and all horizontal joints in the siding panels where water running down the inside of the siding above the horizontal wood surfaces should be repaired to provide the correct protection from water damage with the installation of a “Z” type flashing.

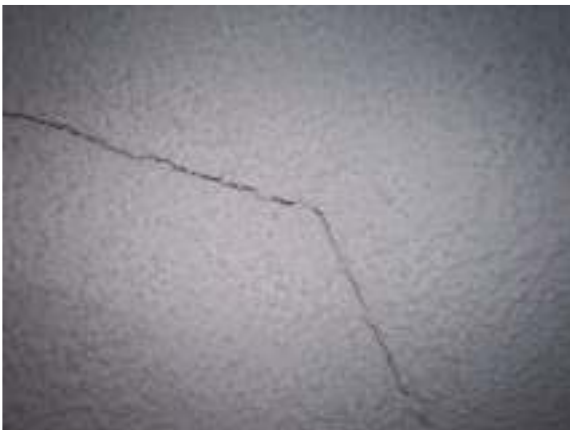
Large crack in the ceiling of the front left bedroom on the pan ceiling is probably caused by the technician that installed the house sound system standing on a vulnerable spot in the roof. Recommend this cosmetic damage be repaired.

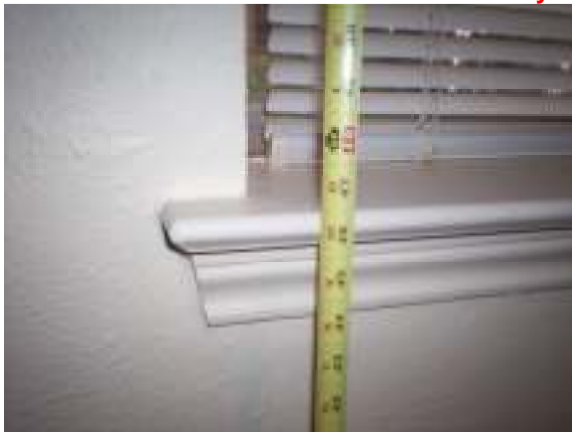
Inspector could not verify that the glass is safety glass over the master bathtub. Recommend verification and correction if necessary for reasons of safety.

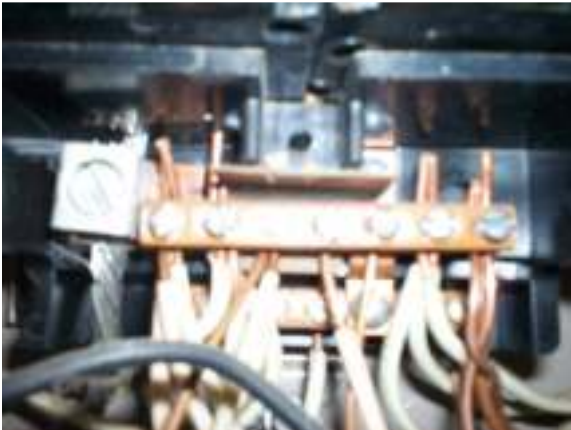
**Neutral wires in the electrical panel(s) are not permitted to be doubled up (double lugged). Each grounded conductor shall terminate within the panelboard on an individual terminal that is not also used for another conductor, except grounded conductors where applicable. Ref 2003 IRC E3606.4 and 1999 NEC 408.41. Recommend a licensed electrician correct as required.**

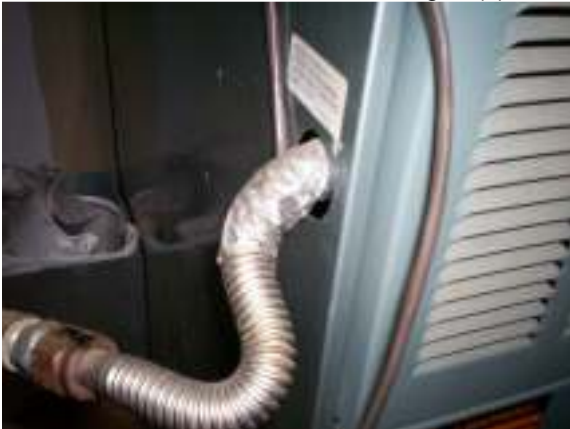
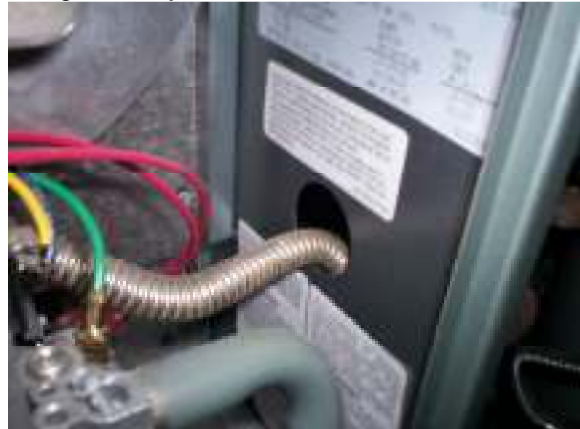
**Flexible gas line is not allowed by current industry standards and most installation instructions to pass into metal cabinet of gas heating units due to the normal vibration from the unit can rub holes in the flexible gas line, rigid metal pipe should extend outside cabinet.**

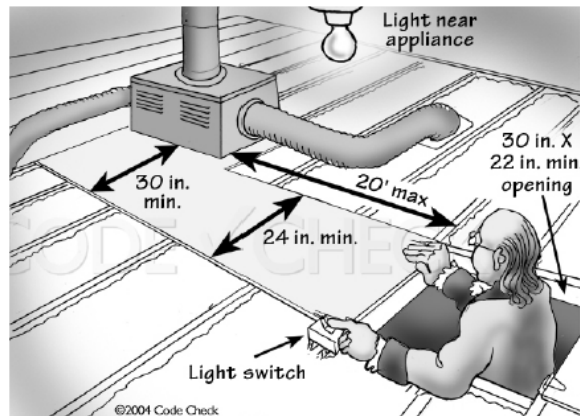
**There is no decked service passage to the attic mounted equipment. Under current IRC standards, all appliances (Air Handlers, Water Heaters, etc) mounted in an attic should be accessible with a passageway of continuous solid flooring not less than 24-inches wide. Reference 2003 IRC 1305.1.3. If the attic mounted appliances require maintenance or replacement the service technician should have a proper working surface to and in the front of the attic mounted appliances.**

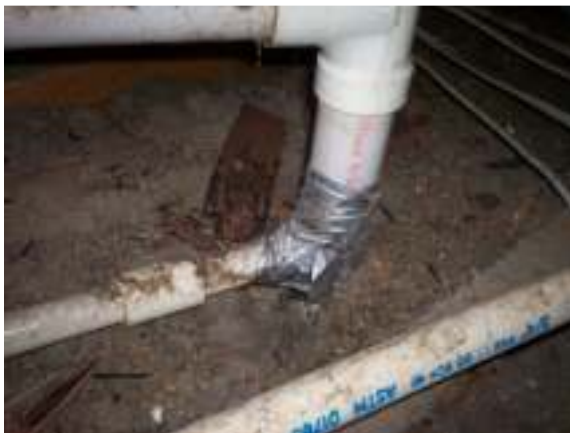
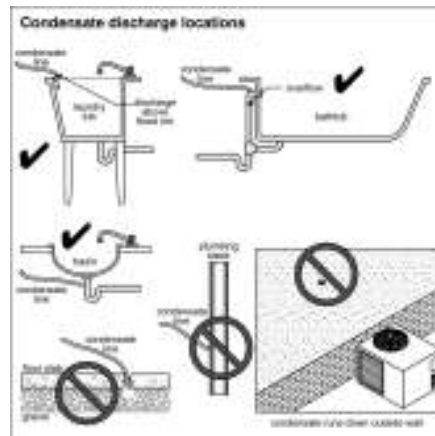
**The primary drain line from the HVAC unit in the attic is not correctly terminated and is not in compliance with building codes and common building practices. This line should terminate into a plumbing drain line typically at a sink, not as it is currently connected directly into a plumbing vent stack pipe. Repairs should be undertaken as the fumes from the vent pipe are caustic and can cause premature corrosion to the HVAC system.**

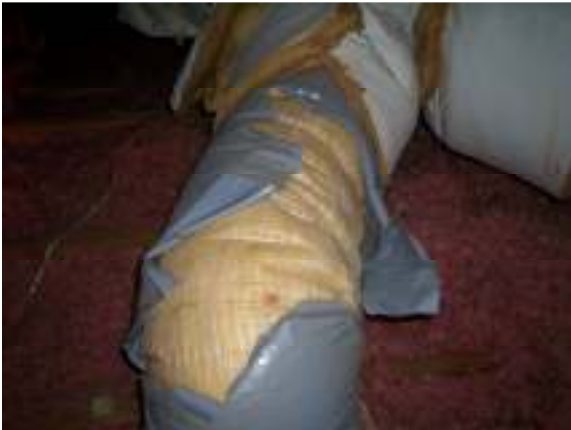
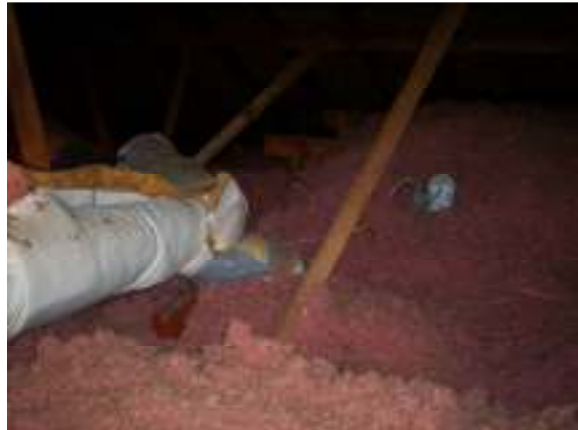
The HVAC ducting in attic is a product known as “first generation gray duct” a recalled product that is well beyond recall statute of limitations. The product is known for high maintenance due to the covering that splits with UV-Ray contact (direct or indirect sunlight through roof vents or penetrations) allowing the insulation to fall off leaving no energy efficiency protection for the conditioned air being distributed to supply registers. Repair is possible (duct tape covering back on after re-attaching the insulation) but ideally, replacement is more highly recommended.

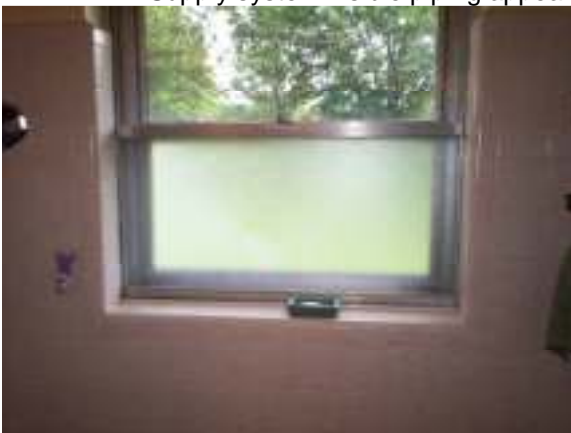
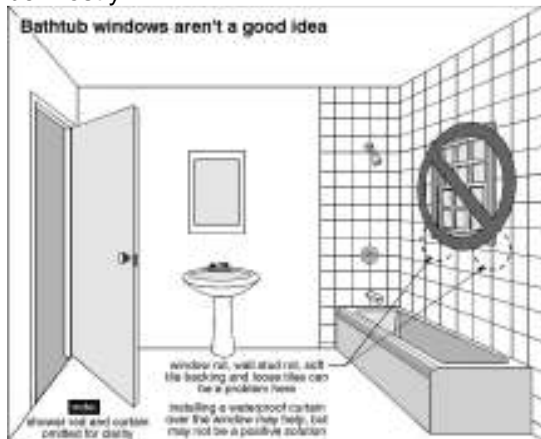
**NOTE: Windows in showers will allow water to penetrate behind the wall. Monitor and repair if it happens. Recommend at a minimum that you install a shower type of curtain over the window to keep the water away from the window.**

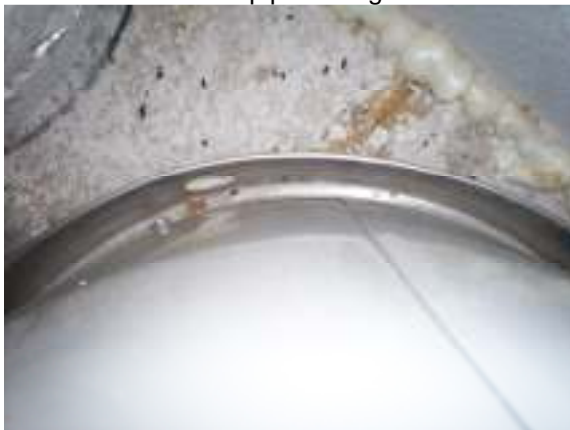
**The pan installed below the water heater located in the upstairs hall is not hooked up to allow any water flowing into it to be discharged to a safe location. Recommend correction.**

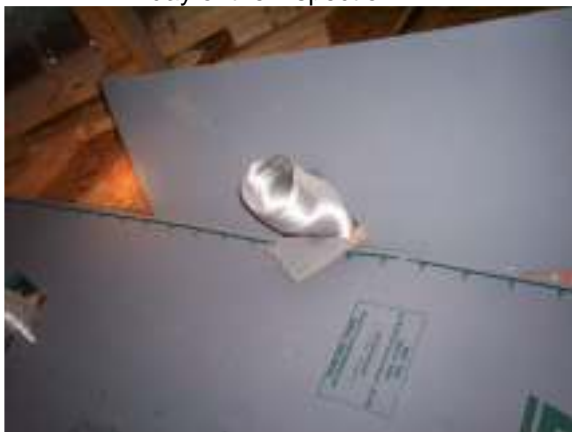
**The laundry exhaust fan(s) should be repaired so as to discharge to the building exterior currently they vent into the attic.**

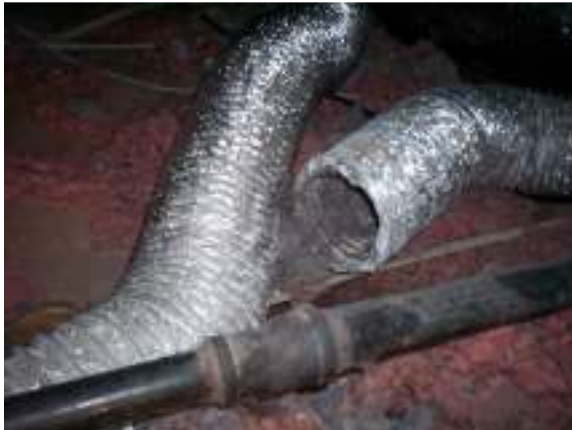
**The clothes dryer vent improperly terminates in the attic / garage, clothes dryer vent shall convey the moisture to the outdoors and shall terminate on the outside of the building Ref IRC 1501.1. Repairs should be undertaken. Lint present in the attic will find it's way into the house, air being drawn into the HVAC system will pull this lint into the HVAC system effectively reducing the HVAC efficiency and furthermore increasing your families coughing and sneezing because of the lint.**

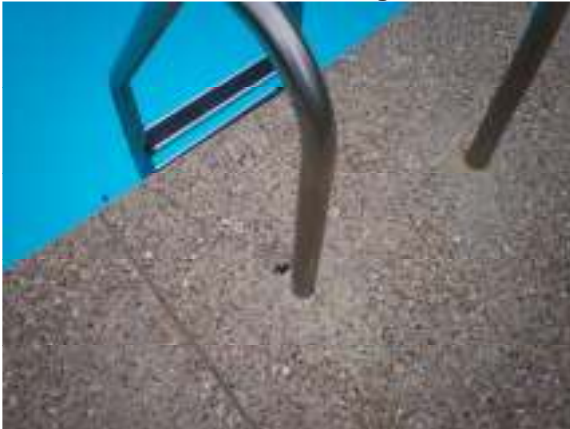
**Cracks noted in the decking of the pool near the ladder, ladder is loose and should be secured. Small cracks with no visual evidence of movement.**

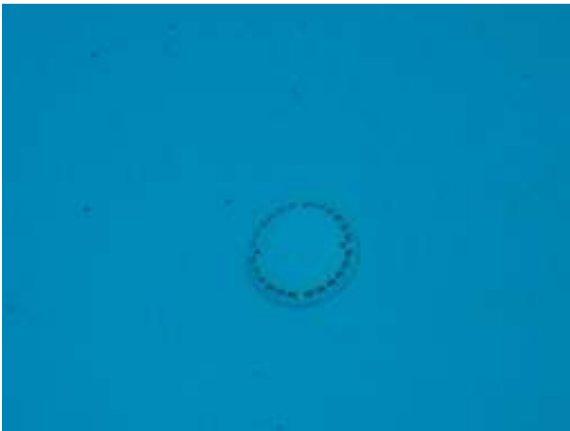
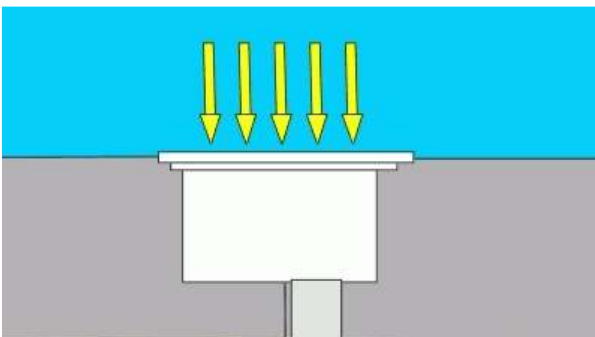
**Simplified drawing of this pool's drain cover**

**Single pool drain noted. Pools being built new today have separated drain covers, this does not allow the suction of the pump to hold someone against the cover. Anti-vortex covers allow water to enter the drain cover from the top and the sides. For reasons of safety I recommend an anti-vortex cover be installed. For sample pictures of anti-vortex covers visit:**

[http://www.mytexasinspector.com/pdf/Anti\\_Vortex\\_ASME\\_ANSI\\_A112.19.8.pdf](http://www.mytexasinspector.com/pdf/Anti_Vortex_ASME_ANSI_A112.19.8.pdf). I did further investigation on this cover, without visually inspecting the cover I cannot be sure of this but it looks like the drain cover in the bottom of the pool is on the acceptable list, if you follow the link above and check out the cover on the bottom of page 4 it looks OK, HOWEVER look at the cover on the bottom of page 3, this is the confusing part. I cannot be sure that this is an acceptable cover. Recommend further investigation.

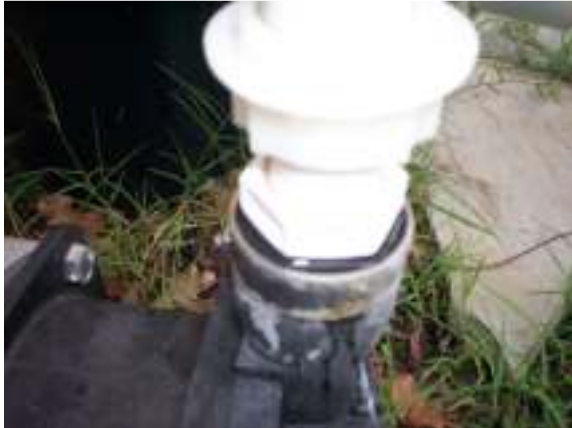
Polaris pump has a water leak where the return line connects on the top of the pump. Recommend a pool technician repair.
