Golden Rule

1 Brand New Home, Anywhere Texas

PROPERTY INSPECTION REPORT

Prepared For: Mr. & Mrs. New Homebuyer's
(Name of Client)

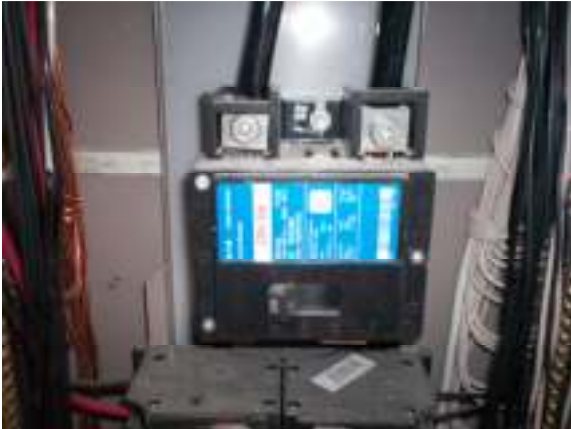
A. Service Entrance and Panels Comments:

Main Power/Cable Entrance Underground. 200 Amp Main Panel Breaker box with main disconnect is located in the garage interior.
