# Golden Rule Property Inspections, LLC

# PROPERTY INSPECTION REPORT

**Concerning:** 123 Main Street, Great Town, Texas

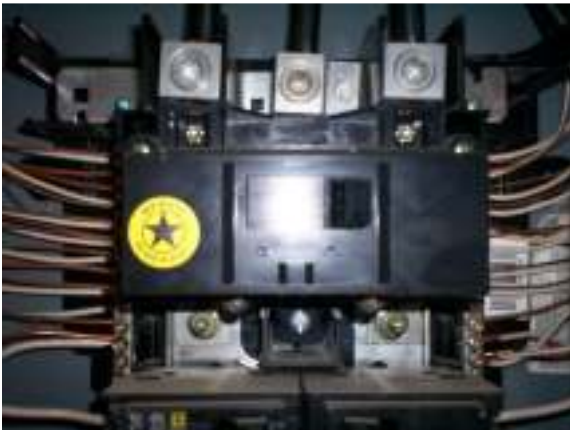
**Main Power/Cable Entrance Underground. 200 Amp Main Panel Breaker box with main disconnect is located in the garage interior.**

**The Texas Real Estate Commission (TREC) requires that all Inspectors note as deficient the lack of Arc Fault Circuit Interrupters (AFCI) devices serving family rooms, dining rooms, living rooms, parlors, libraries, dens, bedrooms, sunrooms, recreations rooms, closets, hallways, or similar rooms or areas, this became effective February 1<sup>st</sup> 2009.**

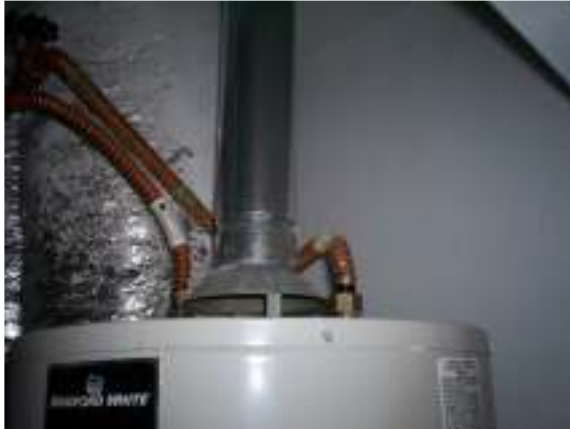
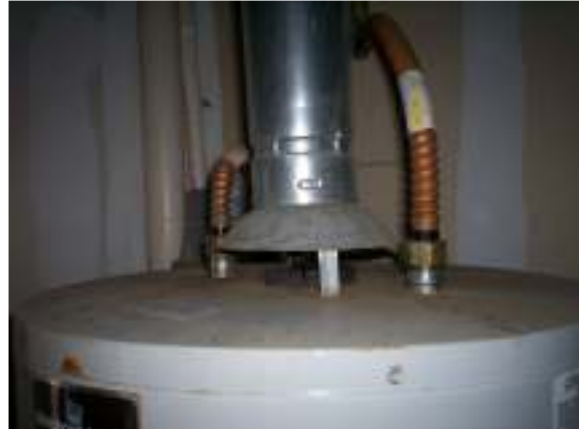
Normal water temperature is 120° - 140°. Water temperature is as measured at the kitchen sink.  
Water temperature is as measured at the sink in the upstairs bathroom.

The TPR valve was not operated as the inspector could not observe the termination point at the time of discharge. The gas shut off valve was present. The type of gas branch line was flexible. The type of observable vent pipe is single & double wall.

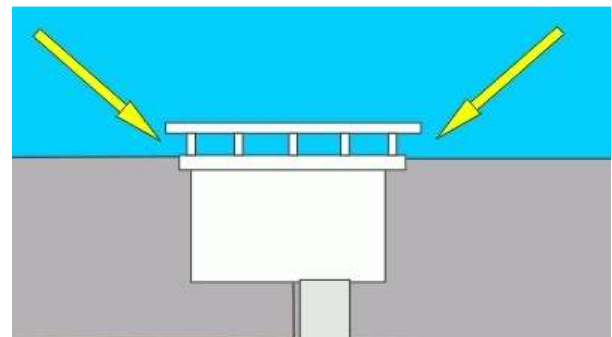
**Simplified version of an Anti-Vortex cover**

**Single pool drain noted. Pools being built new today have separated drain covers, this does not allow the suction of the pump to hold someone against the cover. Anti-vortex covers allow water to enter the drain cover from the top and the sides. For reasons of safety I recommend an anti-vortex cover be installed. For sample pictures of anti-vortex covers visit:**
