**Trus Joist**<sup>TM</sup>  
A Weyerhaeuser Business

# The Silent Floor<sup>®</sup> System Field Guide for Prevention and Repair of Squeaks

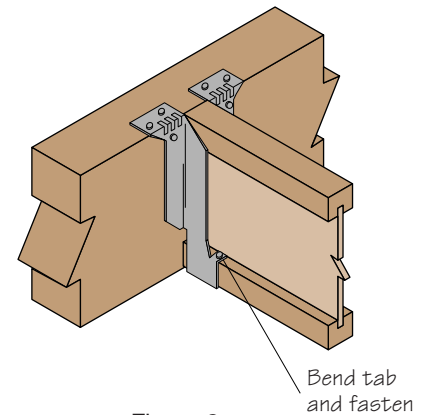
Figure 1

**B. TJI® joists improperly seated in hangers** may create a gap between the bottom of the joist and the seat of the hanger. This gap allows movement when a load is applied, resulting in a squeak (Figure 1).

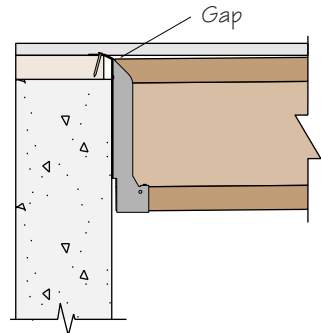
Figure 5

- C. Improper location of sill plate** prevents the top flange of the hanger from being fully supported. When a load is applied, the top flange of the hanger may distort and rub against the face of the concrete or beam, resulting in a squeak (Figure 5).

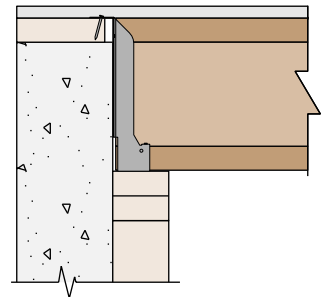
Figure 6

Jack up joist near hanger to eliminate gap and support from below with a stud wall, post or ledger (Figure 6).

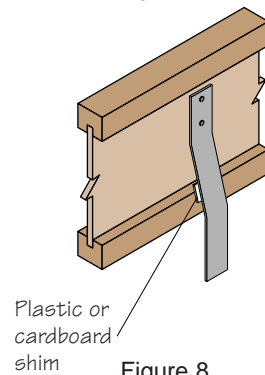
Figure 8

Install a plastic or cardboard shim between the strap and the TJI® joist flange (Figure 8).

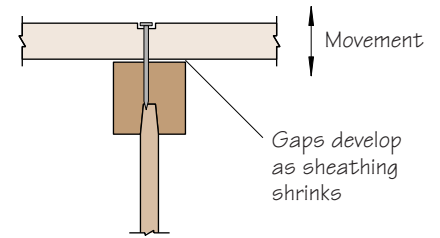
Figure 9

- A. Floor sheathing that gets excessively wet during construction** may swell and shrink later after drying out. The shrinking may leave a gap under the head of the nail allowing the sheathing to move when stepped upon, resulting in a squeak (Figure 9).

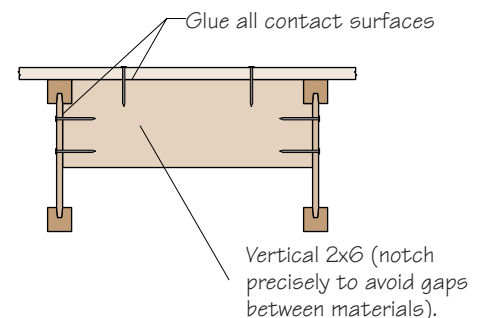
Figure 11

- Adding another layer of structural decking over the existing.
- Installing blocking between the flanges of the joists along the sheathing seams if the floor is accessible from below (Figure 11). Glue all contact surfaces and nail blocking carefully to prevent development of new squeaks.

- Interior partitions should be nailed to the joists.
- Where the partition runs parallel to the joists and extends over more than  $\frac{1}{2}$  of the joist span, a joist should be added under the partition.
- If there is no option but to nail the wall to the sheathing only, run a bead of construction adhesive under the wall and either:
  - Cross-nail (Figure 18).
  - Nail through and clinch the nails tight.
  - Screw from below (Figure 19).
- Another option is to “bridge” between the joists (Figure 11, page 4) and attach wall at blocking locations.

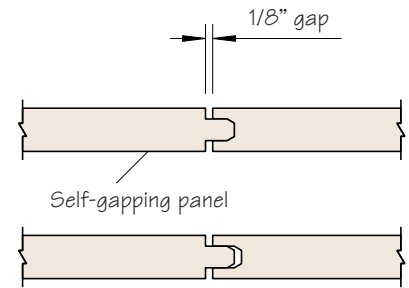
Figure 12

1. Leave  $\frac{1}{8}$ " gap at all edges and end joints for expansion. Some sheathing panels are self-gapping (Figure 12).
2. Glue all tongue-and-groove joints.
3. Glue the sheathing to the joists with adhesives conforming to APA – The Engineered Wood Association performance specification AFG-01 (solvent-based). Apply enough glue to lay only 1 or 2 panels at a time. Apply two lines of glue where panel ends meet. Extend the glue completely across the 48" width of the panel.
4. Complete the nailing of each panel before glue sets.

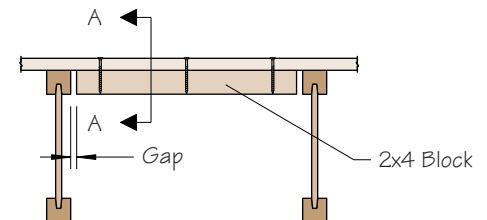
Figure 13

- **For squeaks at the joist**, re-attach the sheathing to the joists with fasteners.
- **For squeaks at tongue-and-groove joints**, screw through the subfloor into a 2x4 block placed directly under the joint. Locate the screws on both sides of the tongue-and-groove joint and glue between the sheathing and the block (Figure 13).
- Cutting a saw kerf at the panel joint may stop the squeak. Be careful not to cut into the joist.

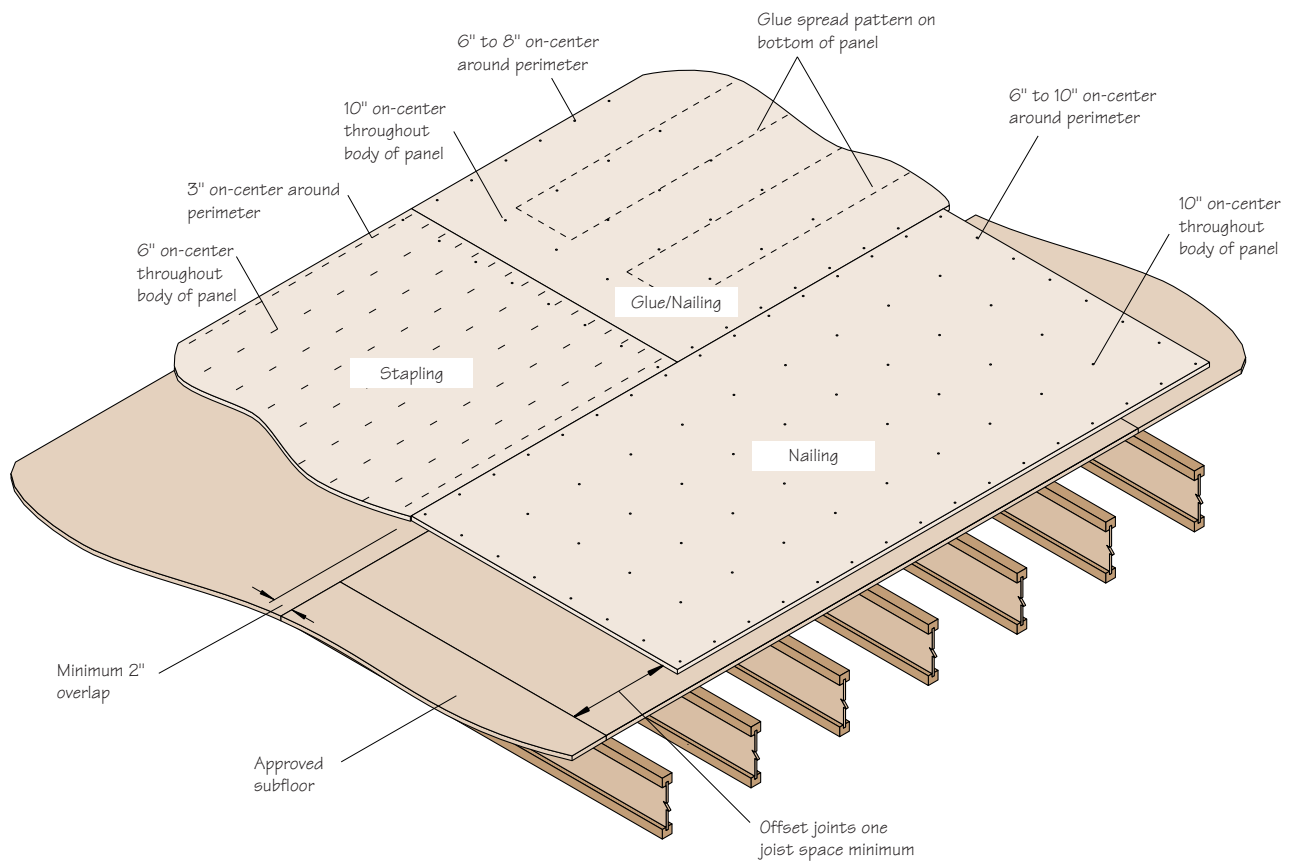
Figure 15

- Follow the underlayment manufacturer's recommendations for installation.
- Sweep and/or vacuum sawdust and other debris from the subfloor before laying the underlayment.
- Offset the underlayment joints from the subfloor joints (Figure 15).
- Properly attach the subfloor to the underlayment by nailing, stapling or glue/nailing (Figure 15).

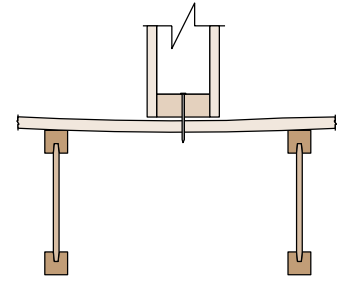
Figure 17

**Floor squeaks at interior partitions** (both parallel and perpendicular to TJI® joists) are usually caused by the partition being nailed only to the floor sheathing. When load is applied, the sheathing deflects and rubs on the shank of the nail, resulting in a squeak (Figure 17).

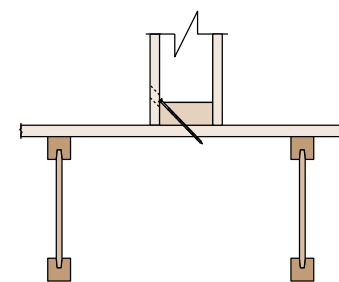
Figure 20

- **If accessible from the underside**, nail up through the floor sheathing and into the bottom plate of the wall. Install screws for better results.
- **If not accessible from the underside**, remove the baseboard along the partition and drill a pilot hole (larger than the screw shank) through the bottom plate of the partition at a 45 degree angle. Install a screw to catch and pull the floor sheathing up to the partition (Figure 20).

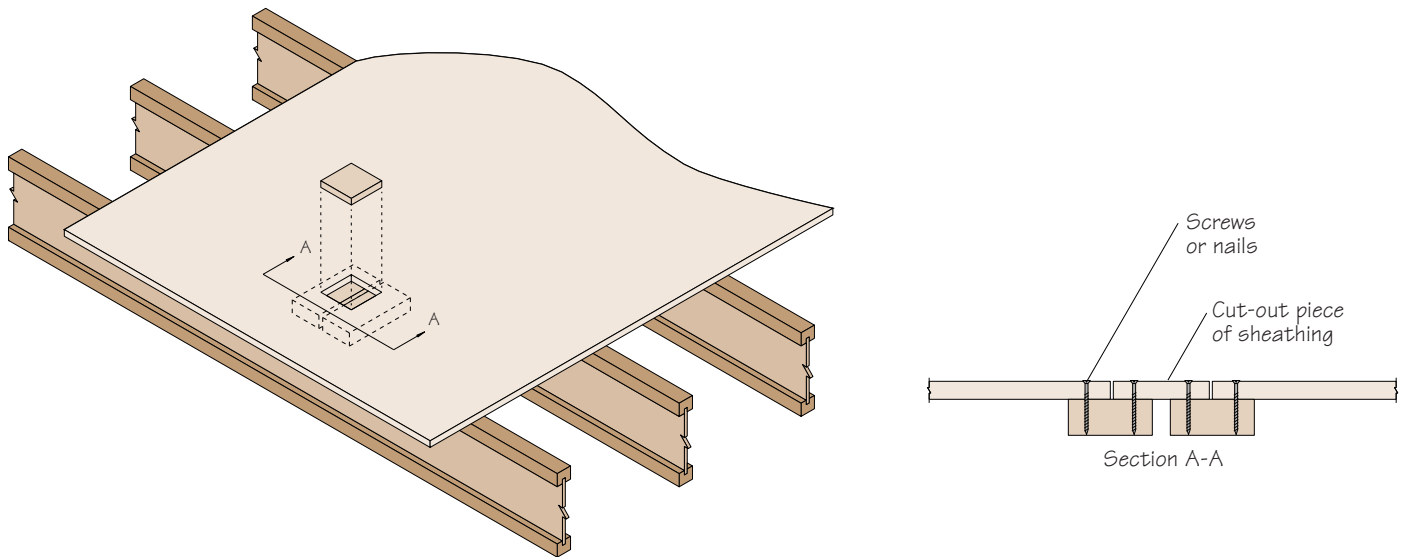
Figure 22

- Access to a floor squeak may be difficult when the finished floor and ceiling have already been installed but may be accomplished by the following method:
  - Pull back the pad and carpet.
  - Locate the joists with the aid of a stud finder or by probing through the sheathing with a pattern of nailing.
  - Drill or cut a 4" hole through the sheathing between the joists.
  - Reach through the hole and fix the problem (shims, nails, glue, etc.).
  - Repair the hole by inserting glue-laden 2x4 blocks through the hole, pulling them up against the underside of the sheathing and screwing them in place.
  - Glue and screw the cut-out piece of sheathing back in place on the 2x4s (Figure 22).
