ALUMINUM WIRE RISK: The Aluminum Electrical Wiring Risks & Hazards Explained

Golden Rule
Property Inspections, LLC
A Locally Owned Professional Inspection Company

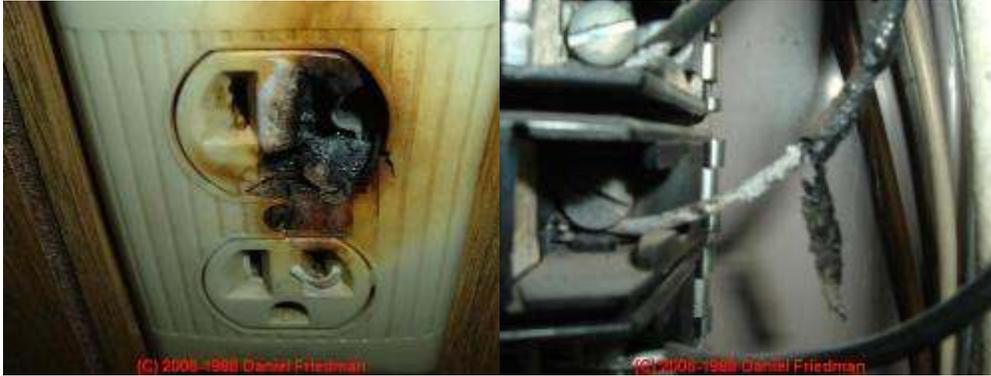
According to the U.S. Consumer Product Safety Commission, fires and even deaths have been reported to have been caused by this hazard. Problems due to aluminum wiring expansion, or much more likely micro-fretting and arcing at the connectors, can cause overheating at connections between the wire and devices (switches and outlets) or at splices. The connections can become hot enough to start a fire without ever tripping a circuit breaker!

The photos shown above are not the most dramatic catastrophes linked to fires caused by aluminum wiring. But these are conditions that are found in many homes with aluminum wiring, confirming that this is a real, common, and widespread hazard.

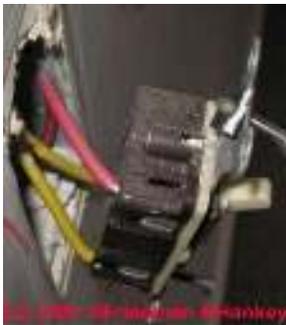
Other methods - not recommended: Warnings regarding other "repair" methods which are not recommended are discussed at [OTHER REPAIR PRODUCTS](#), such as the **Ideal 65 purple "Twister"** connector shown in the photo at left (12 connectors cost \$49. to \$79.), **receptacles and outlets marked "COALR"** (even if these worked, which has not been demonstrated, what about all of the other electrical connections and splices in the building?) and others.

Electrical Receptacles and switches marked "COALR" or CU/AL are also not recommended for aluminum wiring repairs: The photograph shows a back-wired electrical receptacle with an aluminum-wired branch circuit. In this photograph case the electrical receptacle was marked as "AL-CU" but was further marked as Backwire CU-ONLY by its manufacturer. [Photograph courtesy of Roger

Hankey. Contributions of photos of CU-AL and COALR receptacles are sought by the author.].

The photograph shows a back-wired electrical receptacle with an aluminum-wired branch circuit. In these photos the electrical receptacle was marked as *AL-CU* but was further marked as *Backwire CU-ONLY* by its manufacturer.

As we report in more detail below, devices marked AL-CU performed poorly when tested with aluminum wire, and backwiring these receptacles increases the risk of an electrical failure. ["Electrical receptacle" as used in our articles is a synonym for "electrical outlet" or what some people call a "wall plug" or "wall socket".
